Manhole Inspection Summary

Manhole # S39QQ_008MH

Insp Date: **4/4/07 9:25 AM**

Location Address: **776 KIRK AVE**

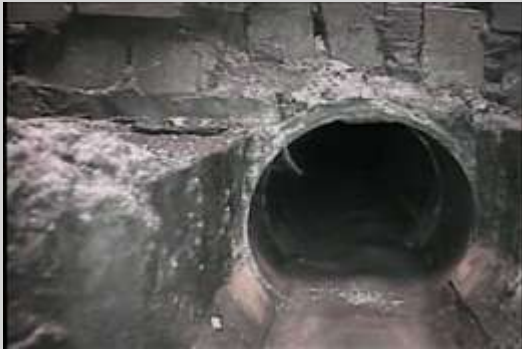
8 in. Circular Gravity Sewer Pipe Out @ 12 O'Clock

Rod and Bar (Angled)

Pipe Material: **Clay** ☐ Pipe Lined

Invert Depth: **7.97** (ft.) Flow Characteristics: **Slow**

Deposits: ☒ None ☐ Mud ☐ Sludge ☐ Debris ☐ Grease

Infiltration: **None** Pipe Seal Cond: **Unknown**

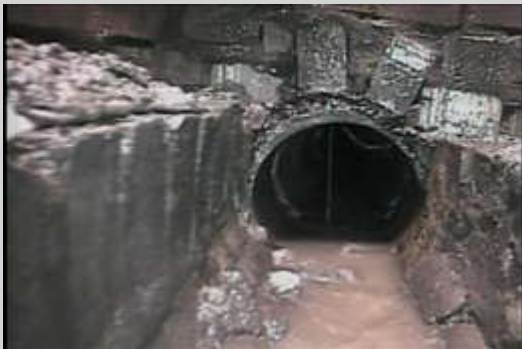
8 in. Circular Gravity Sewer Pipe In @ 6 O'Clock

Rod and Bar (Angled)

Pipe Material: **Clay** ☐ Pipe Lined

Invert Depth: **7.65** (ft.) Flow Characteristics: **Slow**

Deposits: ☒ None ☐ Mud ☐ Sludge ☐ Debris ☐ Grease

Infiltration: **None** Pipe Seal Cond: **Unknown**

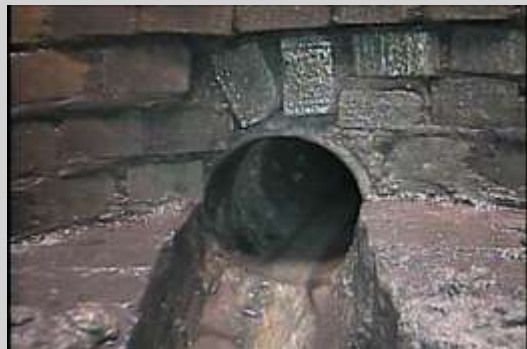
8 in. Circular Gravity Sewer

Rod and Bar (Angled)

Pipe Material: **Clay**

Infiltration: **None**
